BROOKHAVEN NATIONAL LABORATORY

Work Permit # DRL-2010-2
Work Order # _____
Job# _____ Activity# _____

Attachment to W.P. # DRL-2010-2 January 25, 2010

Drift Chamber repair in the PHENIX Experimental Hall (bldg. 1008).

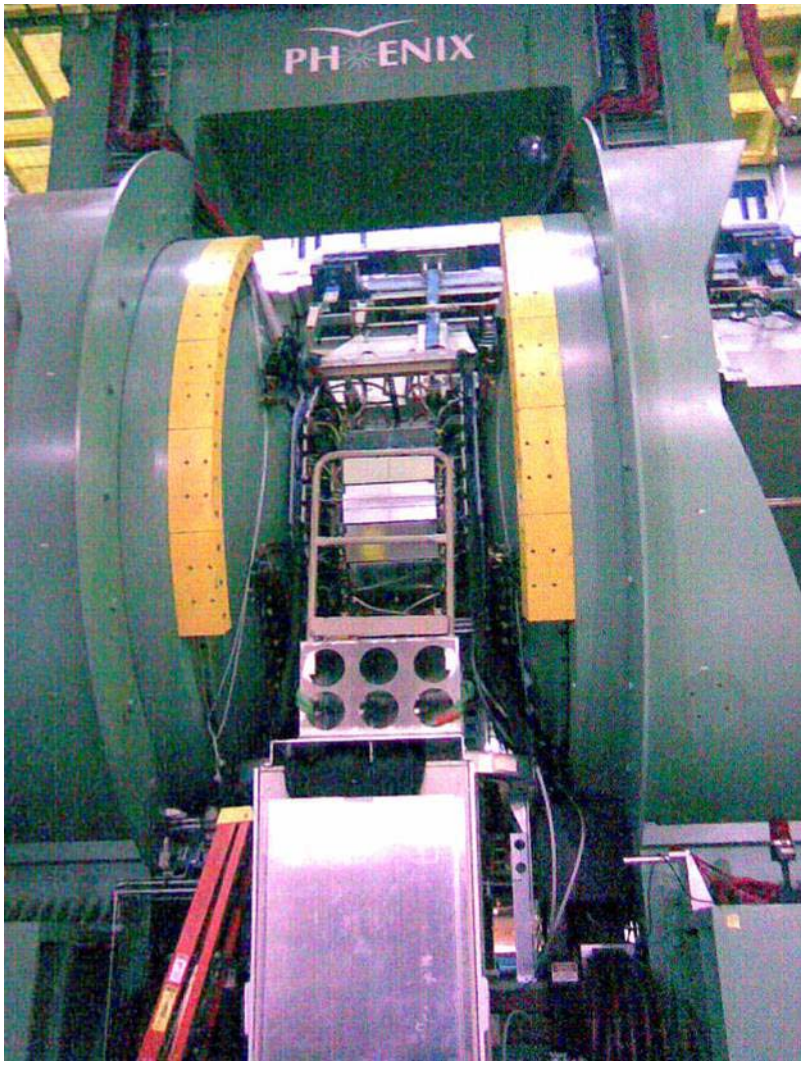
4. Safety rail on elevation step must be attached as shown in the photo below.

CM Lift Table Extension Step and safety rail
